**Spectroscopic study of collapsing soil microstructure to explore the
physical properties afterward incorporating textile wastes**

Abstract

Keywords: textile sludge; collapse potential; XRD; EDAX; SEM; FTIR

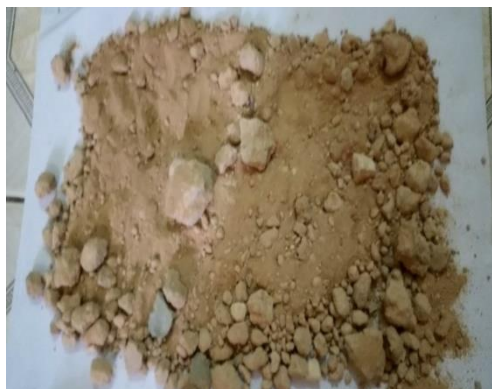
According to Abbas et al. (2021), the soil used in this study comes from the Borg el-Arab region in northern Egypt, which is roughly 62 kilometres west of Alexandria. As indicated in Fig. 1, collapsible soil appears to be a yellow or brown silty sand interlocked with a crack of limestone. Soil samples were oven-dried before being processed through sieve #40. The physical properties of the soil were then calculated, as shown in Table 1.

Fig. 1 Collapsible soil

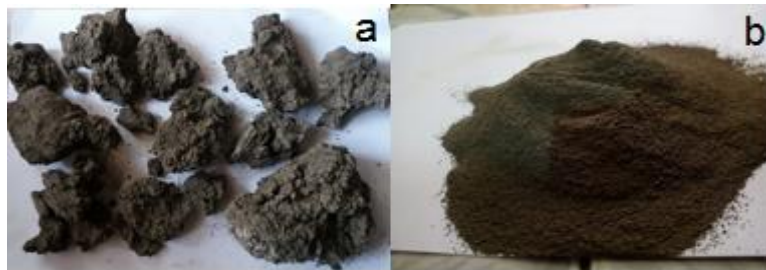
According to Abbas et al. (2021), The textile sludge (T.S) was taken from a textile Plant in Tanta, Egypt. As illustrated by Fig. 2, the sludge was oven dried before being crushed and passed through sieve #40. Table 2 shows the chemical characteristics of textile sludge measured using ICP (inductivity coupled plasma).

Fig. 2 Textile sludge: (a) before crushing; (b) after crushing (Abbas et al., 2021)

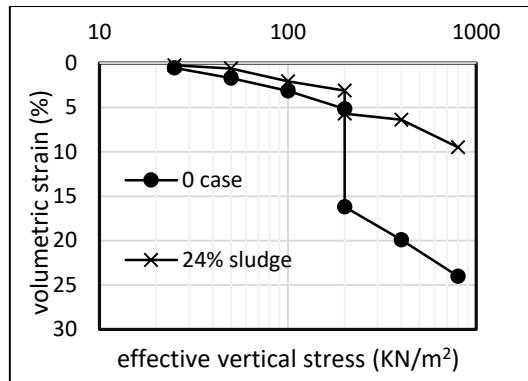
Collapse potential was significantly decreased by adding 24 percent textile sludge to collapsible soil, reaching a value of 76.36%, as revealed by the decline in volumetric strain at 200 KN/m² in Fig. 3 (Abbas et al., 2021).

Fig. 3 Oedometer results for soil and soil mixed with 24% of textile sludge (Abbas et al., 2021)

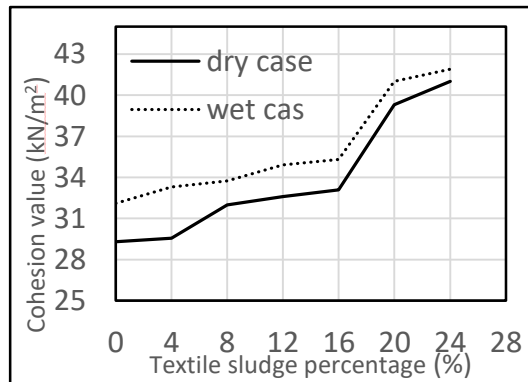
On both dry and wet samples, Abbas et al. (2021) performed a direct shear test. The cohesiveness value of collapsible soil increased when 24% of textile sludge was added. Cohesion rose from 29.3 KN/m² to 41 KN/m² for dry samples. While in the case of wet samples, as seen in Fig. 4, the cohesiveness value rose from 32.1 KN/m² to 41.9 KN/m².

Fig. 4 Effect of textile sludge on cohesion value (Abbas et al., 2021)

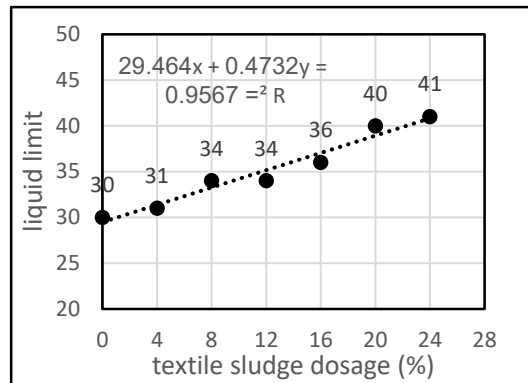
According to Fig. 5, when textile sludge was added to soil at a rate of 24%, the liquid limit value of the collapsing soil increased from 30% to 41% (Abbas et al., 2021).

Fig. 5 Effect of textile sludge o liquid limit value

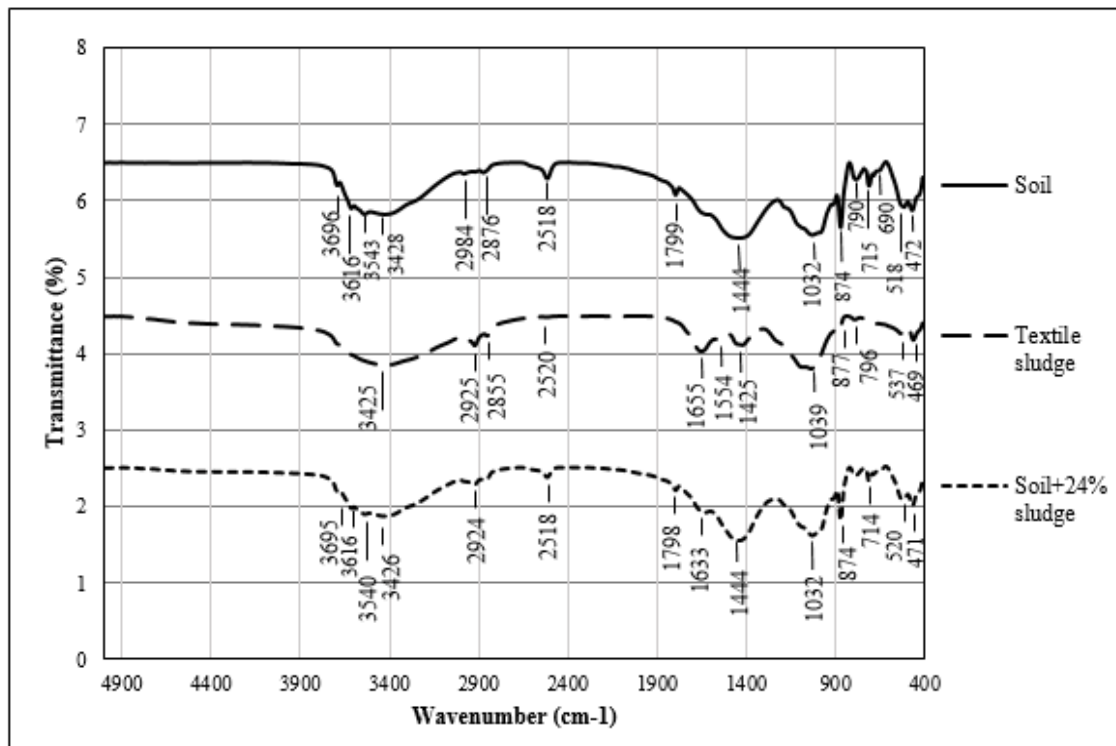
FTIR results of soil, textile sludge, and soil mixed with 24% of textile sludge are illustrated in Fig. 7. For collapsible soil, the vibration mode of the bands at 1444, 874, and 715 cm^{-1} indicated the presence of calcite structure in the sample (Galván et al., 2009; Sun et al., 2014). Also, weak peaks around 1790–1800 and at 2518 cm^{-1} may refer to the existence of calcite (Zhan et al., 2018). The strong band at 790 cm^{-1} and the weak band at 690 cm^{-1} refer to the presence of quartz (Sathya et al., 2012). The band at 472 cm^{-1} comply with the Si–O bending band vibration (Lee et al., 2013). The peak at 1032 cm^{-1} derived from in-plane Si–O stretching modes and refer to kaolinite band. Crystallized kaolinite could be also concluded from the presence of OH bands at 3696 and 3616 cm^{-1} (Martens et al., 2002; Yin et al., 2019). The presence of such transmission peaks in the FTIR results of soil shows the main minerals in soil which in turn confirms the XRD results.

Textile sludge spectrum shows bands at 796 and 469 cm^{-1} which confirm the existence of aluminum and silicon in sludge as it refers to vibration modes of O–T–O groups and the bending vibrations of T–O bonds, respectively where (T = Si and Al) (Mansouri et al., 2013). Band at 537 is due to Out-of-plane C=O bending (Kong & Yu, 2007) and bands at 874 and 1425 cm^{-1} indicate a higher amount of carbonates. Two broad bands are found at 1554, 1655 cm^{-1} refer to (amide II and amide I respectively), The broad band at 3400 cm^{-1} usually appears in wastes and it assigned to hydroxyl groups and water (Smidt & Schwanninger, 2005). The transmission band at 1039 could refer to C–O stretching, although aliphatic methylene groups are found at 2925 and 2855 cm^{-1} . Most of the previous bands represented parts of many organic molecules which supports an important function of textile sludge that could affect the water holding

For soil sludge mixture, the band at 2924 cm^{-1} , may refer to the presence of aliphatic groups (CH) in the mixture (Gokulakumar & Narayanaswamy, 2008). Aliphatic methylene groups and amide bands, could be indication of the presence of organic matter which play a vital rule in fermentation process and production microorganisms in a large amounts to reduce the cost of soil clogging through blocking the pores of soil by suspended particles of sludge (Ivanov & Chu, 2008). The broad peaks at 1633 cm^{-1} and 3426 cm^{-1} refer to the hydroxyl groups and water absorbed on the surface (Cheng et al., 2017). Accordingly, adding textile sludge to soil improves its water holding capacity and as a result, an increase in the initial water content of soil will occur and lead to decrease in suction and consequently decrease in collapse (Ali, 2014). Increasing the water holding capacity also affected on increasing the liquid limit value of mixtures.

Fig. 7 FTIR transmission spectra of soil, textile sludge and soil +24% textile sludge

2) According to the FTIR data, adding textile sludge to the soil produces organic matter and, hence, microorganisms, reducing soil collapsibility and the expense of soil clogging. Textile sludge additionally improved the soil's capacity to retain water, which raised the liquid limit.

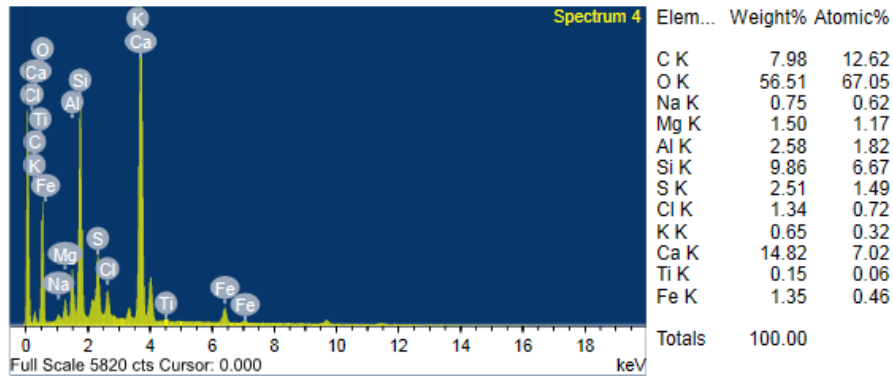
The SEM micrograph of textile sludge in Fig. 8a indicates the aggregate shapes of sludge particles with the non-uniform distribution. In Fig. 8b, the EDAX elemental analysis of textile sludge shows that oxygen(O) and carbon (C) are the main components of textile sludge with additional high peaks of silicon (Si) followed by aluminum (Al), magnesium (Mg), calcium (Ca), iron (Fe). the presence of such elements plus the presence of high oxygen content could refer to the presence of the following oxides (SiO_2 , Al_2O_3 , MgO CaO , and Fe_2O_3) which are the main oxides to form a pozzolanic reaction (Amiralian et al., 2015). EDAX result of textile sludge also indicates traces of certain elements such as (Na, K, Cl, Ti, Cu, P, and Zn). The SEM micrograph of collapsible soil Fig. 9a shows a large inter aggregates pores, these pores could be classified as bracket pores. This type of pores has a larger diameter than its surrounding particles and has more ability to collapse (Xie et al., 2018). The EDAX spectroscopy in Fig. 9b shows the presence of a high percentage of oxygen (O), calcium (Ca), silicon (Si) and carbon (C) with small proportion of some components such as Al, S, Mg, Fe, Cl, Na, K, and Ti. SEM of soil treated with textile sludge Fig. 10a, bracket pores has been converted into mosaic pores, these pores have a volume smaller than the surrounding particles and less susceptible to compressibility and collapse (Xie et al., 2018), it is also noticeable that after adding sludge, the constituents of the soil as sand, silt, and clay particles cannot be configured out obviously which confirms the cementitious effect of the sludge and confirms also the homogenous distribution of sludge particles through soil samples. The EDAX spectroscopy in Fig. 10b, explains the presence of a high percentage of

Fig. 9: (a) (SEM) for collapsible soil; (b) (EDAX) for collapsible soil

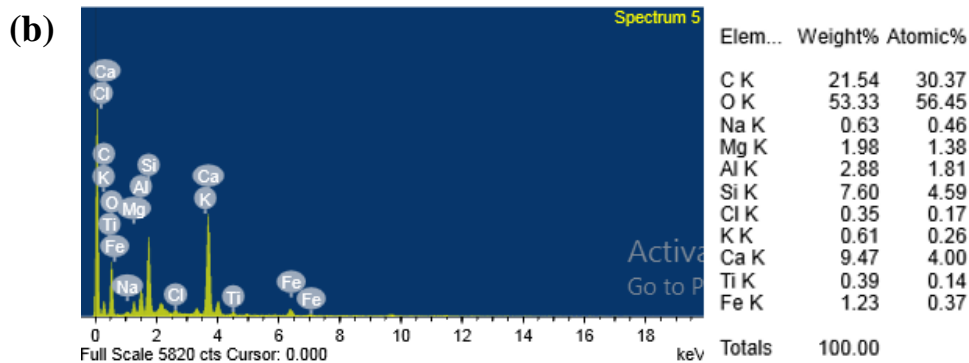
oxygen (O), carbon (C), calcium (Ca) and silicon (Si) with small proportions of some elements such as Al, Mg, Fe, Na, K, Cl, and Ti.

Fig. 10: (a) (SEM) for collapsible soil treated with 24% of textile sludge;
(b) (EDAX) for collapsible soil treated with 24% of textile sludge.

3) The treated soil's SEM results revealed a homogenous compact structure, and the bracket pores had transformed into mosaic pores, which are less prone to collapse.
